Manhole Inspection Summary

Manhole # S27K__021MH

Insp Date: **6/3/08 10:32 AM**

Location Address: **side of 857 Ramsay St** Cross Street: **S Poppleton St**

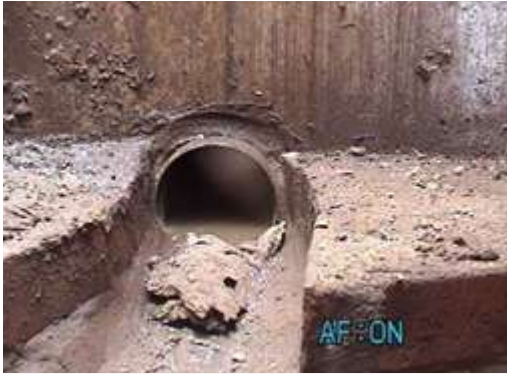
Miscellaneous

Condition: ☐ Sound ☐ Cracked ☐ Root Intrusion ☐ Deteriorated ☐ Leaks ☒ **Debris**

debris in channel

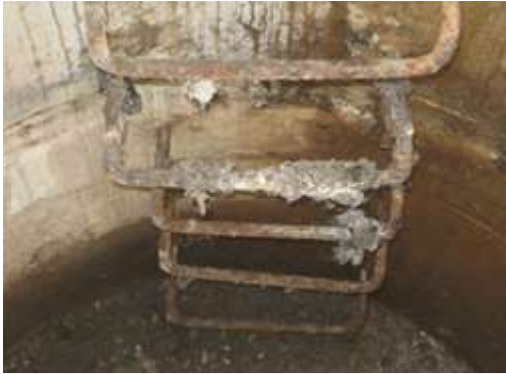
Defect 2

Surcharge ☒ **Evidence Of Surcharge** Depth: **6** (ft.) ☐ Active Surcharge Present

surcharge 6

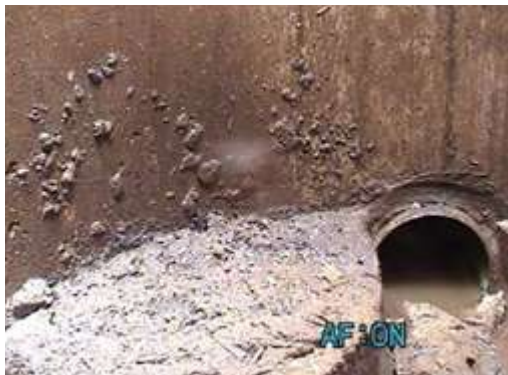
Defect 1

debris on bench

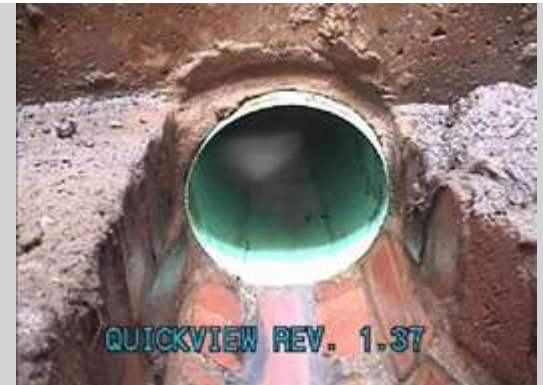
12 O'Clock Outflow

Pipe Height: **8.4** (in.) Rod and Bar (Angled)
Pipe Material: **PVC** ☐ Pipe Lined
Invert Depth: **8.49** (ft.) Flow Characteristics: **Slow**
Deposits: ☒ None ☐ Mud ☐ Sludge ☐ Debris ☐ Grease
Silt Depth: **0** (in.) Deposits Extent:
Infiltration: **None** Pipe Seal Cond: **Sound**

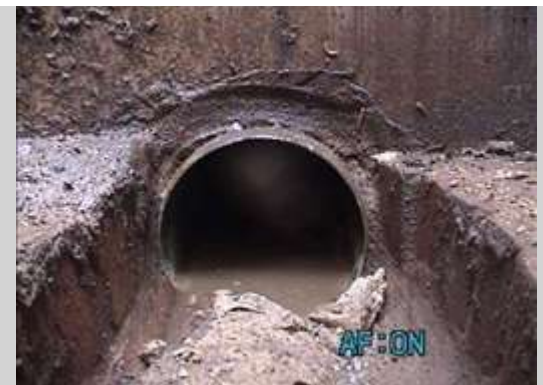
3 O'Clock Inflow

Pipe Height: **8.4** (in.) Rod and Bar (Angled)
Pipe Material: **PVC** ☐ Pipe Lined
Invert Depth: **8.44** (ft.) Flow Characteristics: **None**
Deposits: ☒ None ☐ Mud ☐ Sludge ☐ Debris ☐ Grease
Silt Depth: **0** (in.) Deposits Extent:
Infiltration: **None** Pipe Seal Cond: **Sound**

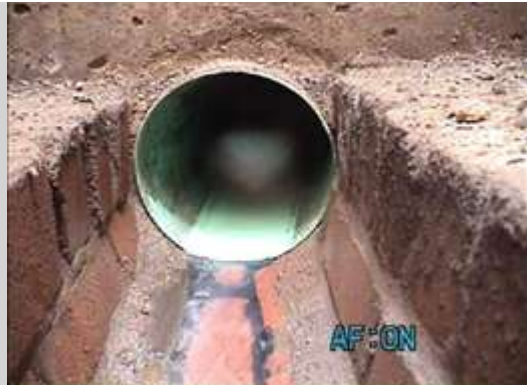
6 O'Clock Inflow

Invert Depth: **8.40** (ft.) Flow Characteristics: **Slow**

Infiltration: **None** Pipe Seal Cond: **Sound**
